Induced AC Interference Testing Case History

Jeff Didas
Colonial Pipeline Company
Mike Placzek
Spectra Energy

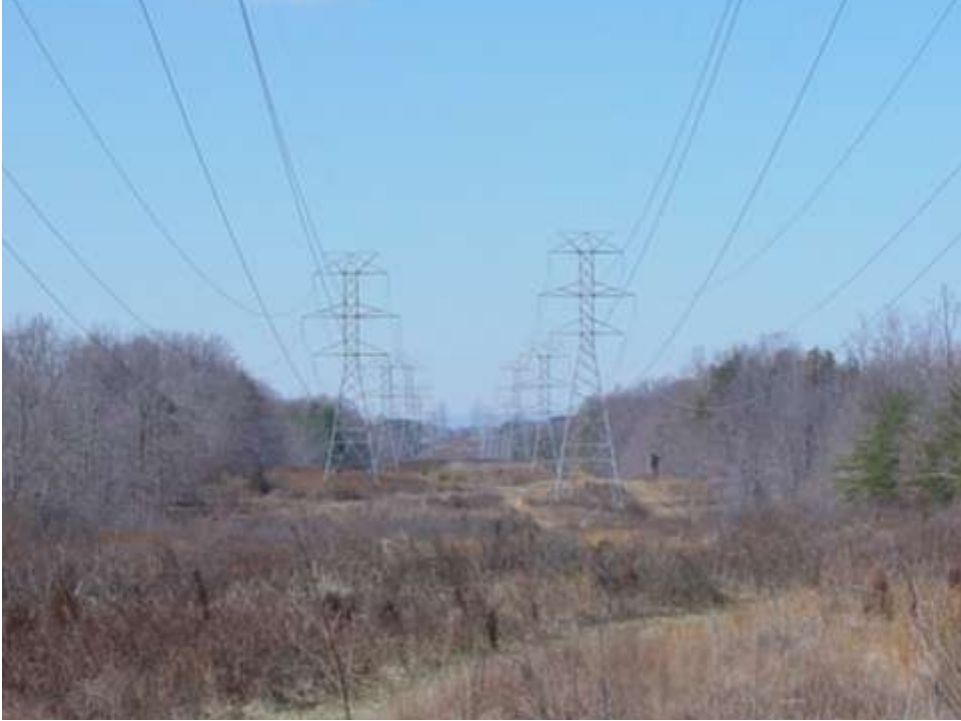
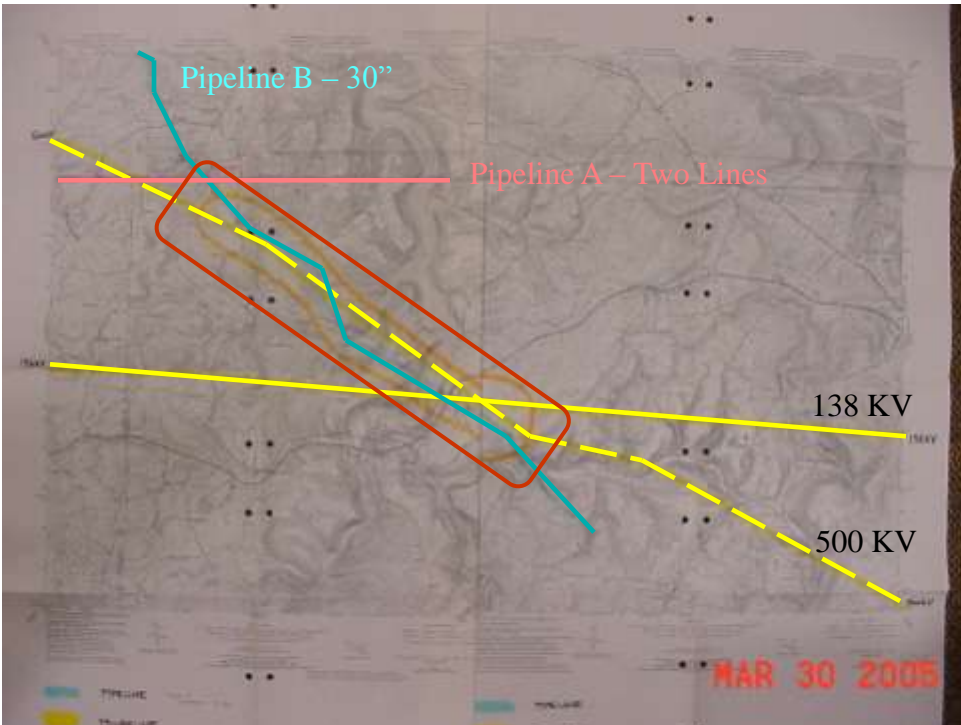
- Both pipelines A & B parallel and/or ingress/egress high voltage AC power line corridors in this area and there is a large AC interference component on both pipelines.
- Operator A & B schedule some mutual interference testing at the site to determine what is the cause of the coating failures. The testing (AC & DC potentials) is conducted on the site and it is determined that the AC is causing the coating failures. Faults, lightning and other surges along the power lines and pipelines are possible causes for coating failures when the AC currents discharge off the pipeline.

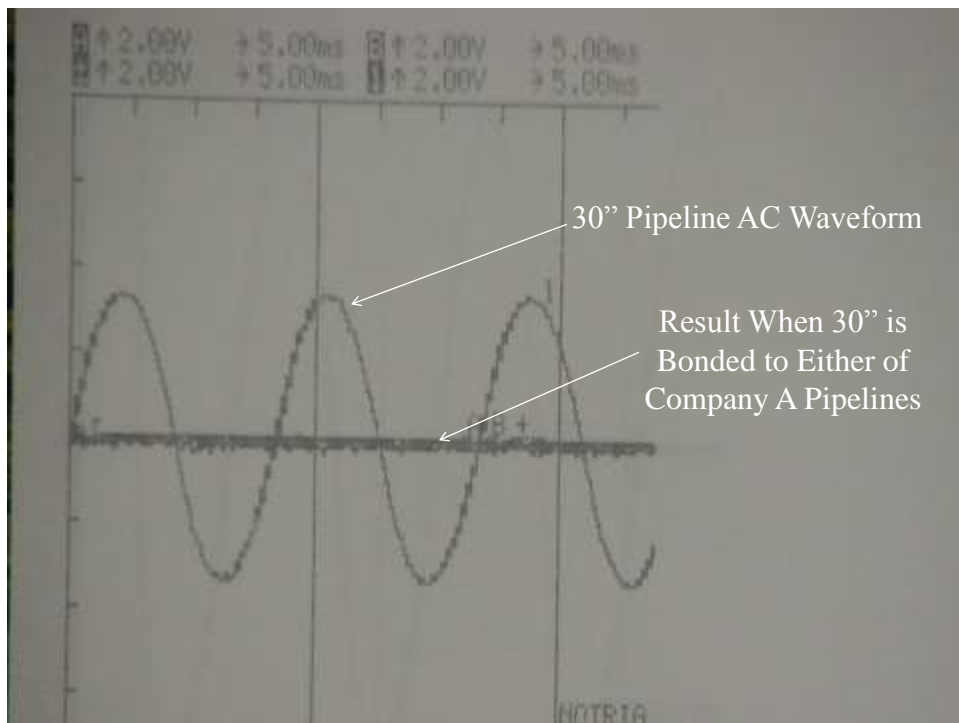
- Further testing (taking voltage measurements using an oscilloscope) and discussions revealed the following:
- Pipeline A is paralleling a power line different from the power line along Pipeline B.
- The induced AC voltage on Company A's pipelines and Company B's pipeline were practically 180 degrees out of phase. The induced voltages varied between 5 and 45 volts AC.
- Both power lines have a history of faults, lightning and other surges in this area.

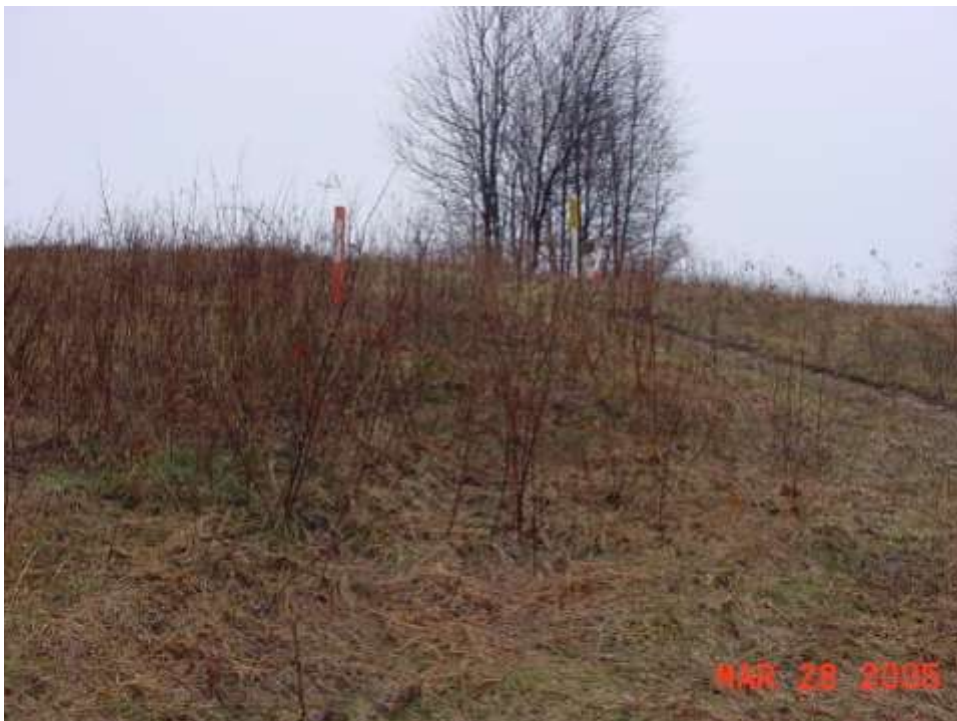
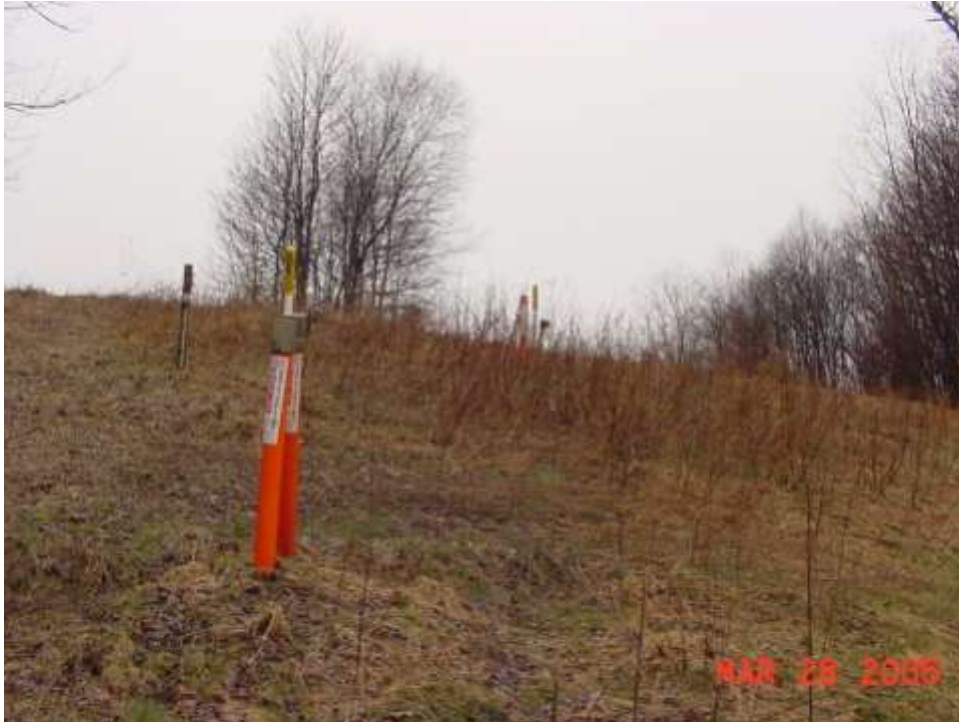
- Zinc grounding cells were installed and allowed to operate. AC current was able to flow through Pipelines A & B via the cells and the discharge points were eliminated. The AC current was discharged via the zinc anode beds back to the power line sources.
