Cathodic Protection for AST's

Presented by:
James T. Lary
Corrpro Companies, inc.
1055 West Smith Road
Medina, Ohio 44256
jlary@corrpro.com
330-241-6615

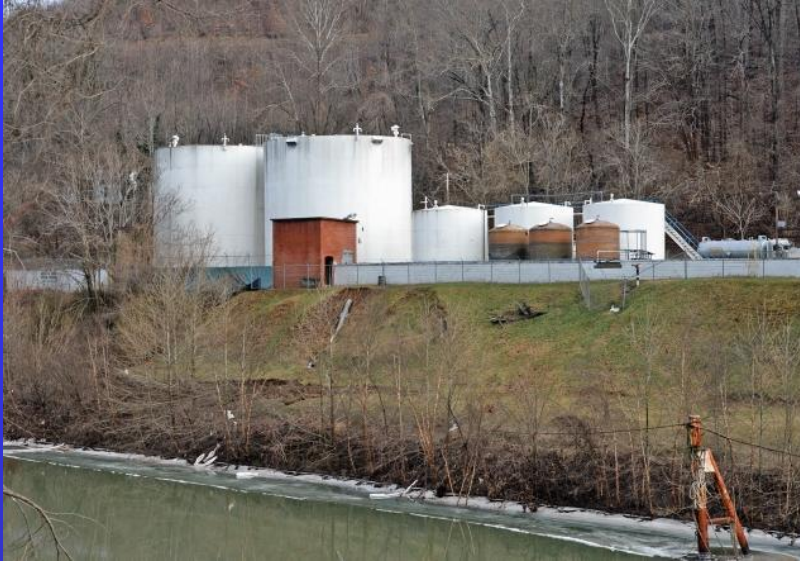
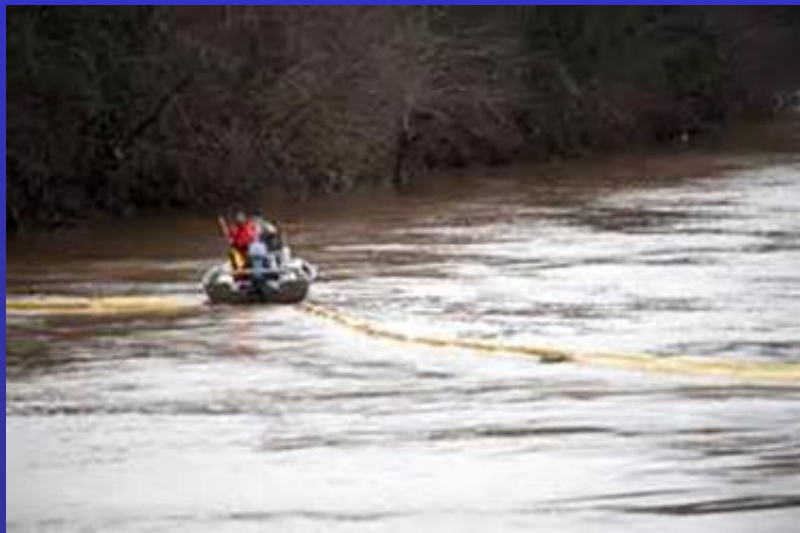
Charleston, WV Spill

The investigation found that two small holes ranging in size from about 0.4-inch to 0.75-inch in the bottom of the 48,000-gallon tank 396 were caused by corrosion, likely resulting from water leaking through holes in the roof and settling on the tank floor. Furthermore, the CSB inspection found a similar hole penetrating the bottom of nearby tank 397, containing the same chemical at the facility, located in Charleston. Other tanks also showed multiple signs of pitting and metallurgical damage, investigators said. The growing corrosion in these tanks went unnoticed until the bottom of 396 was breached and up to an estimated 10,000 gallons of product made their way through the underlying mixture of soil and gravel under the facility and into the Elk River on January 9, 2014.

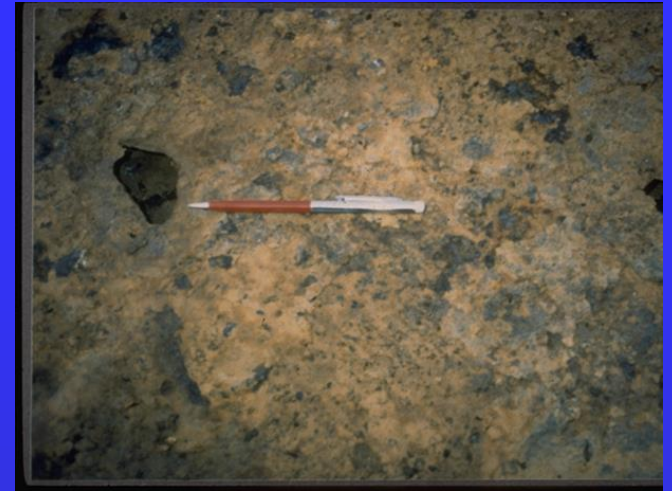
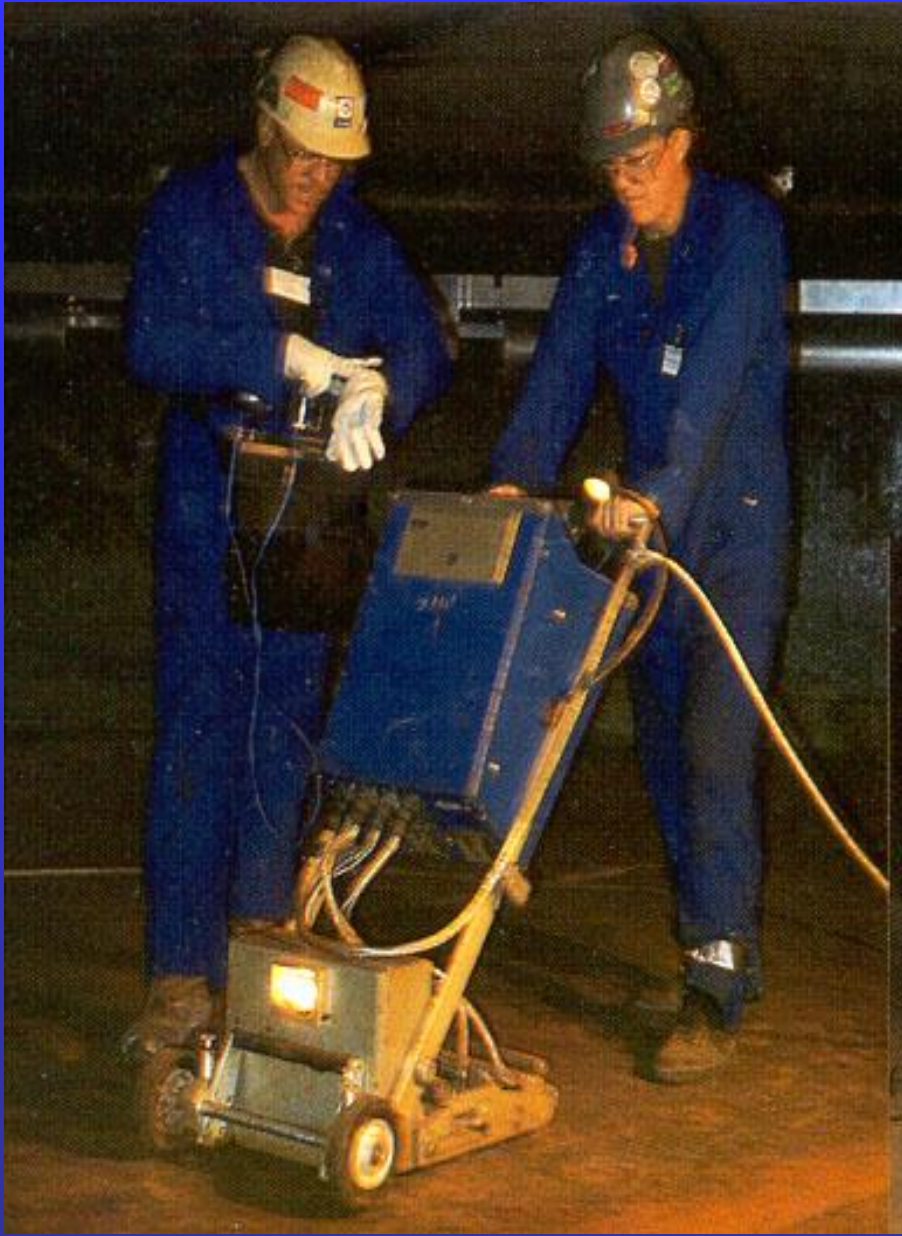
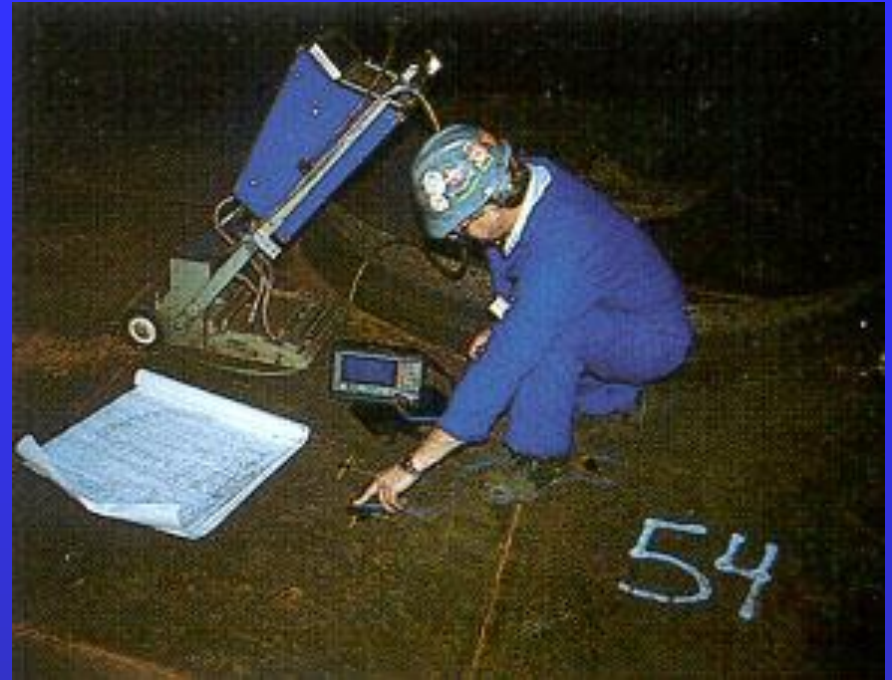
External Corrosion of Tank Bottom

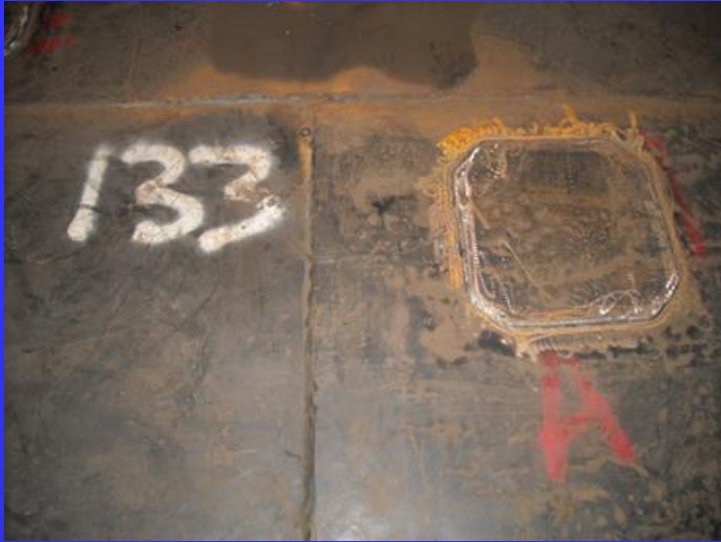
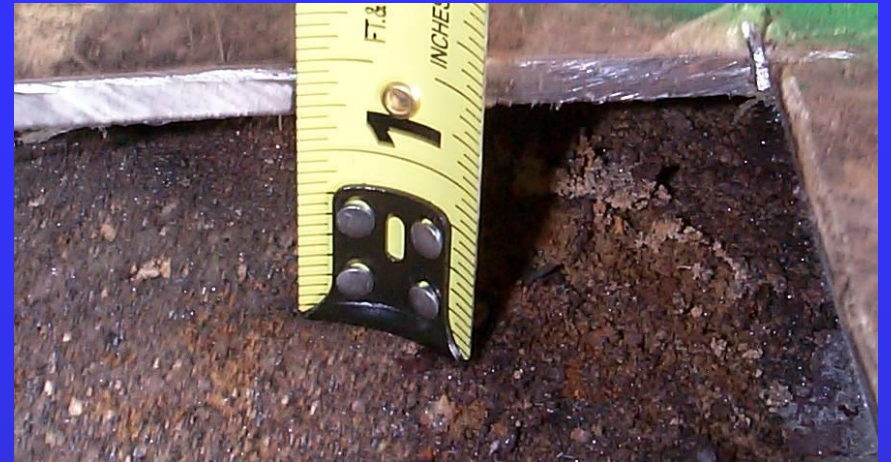
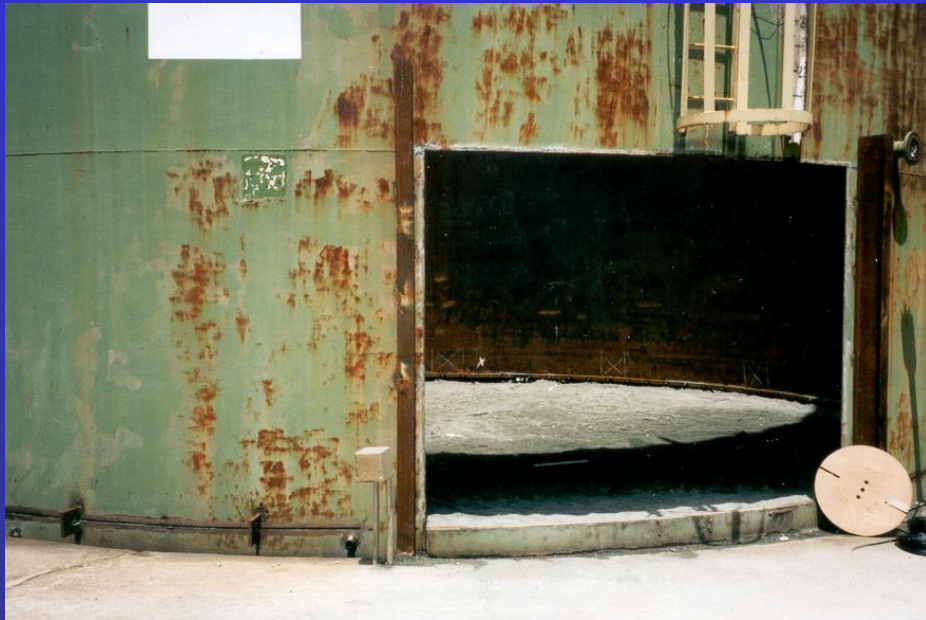
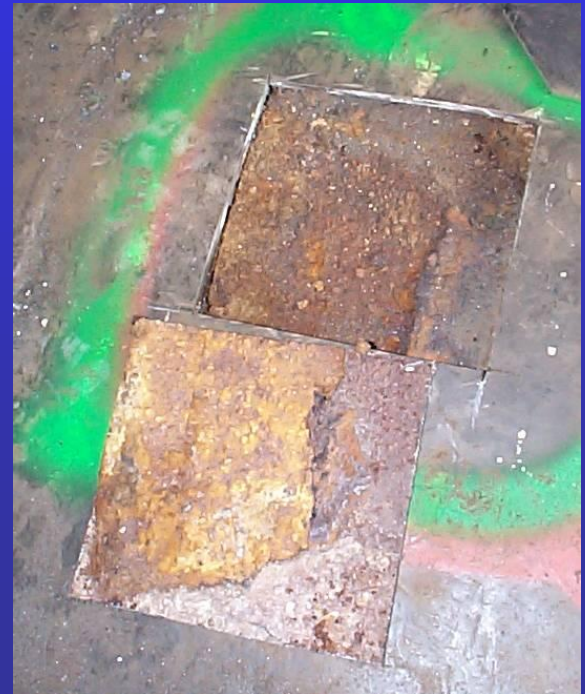
MFL Floor Inspection

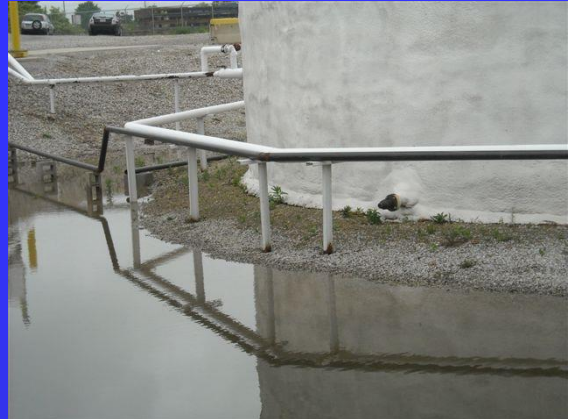
Corrosion Caused by Poor Water Drainage

WATER

MOIST SAND

DRY SAND

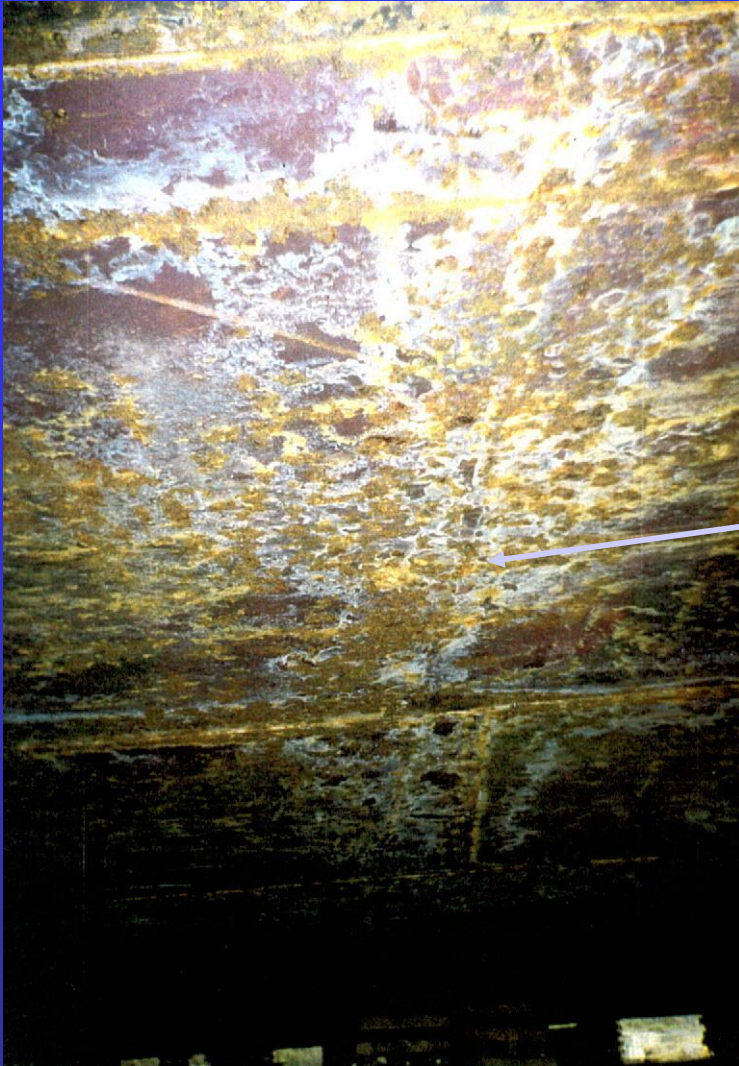
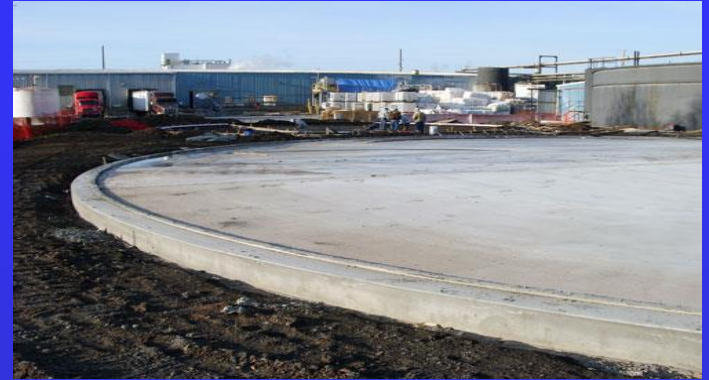
Concrete Slab

Leak detection groove
under under bottom

Tank bottom required
30% floor
replacement
after 5 years in
service

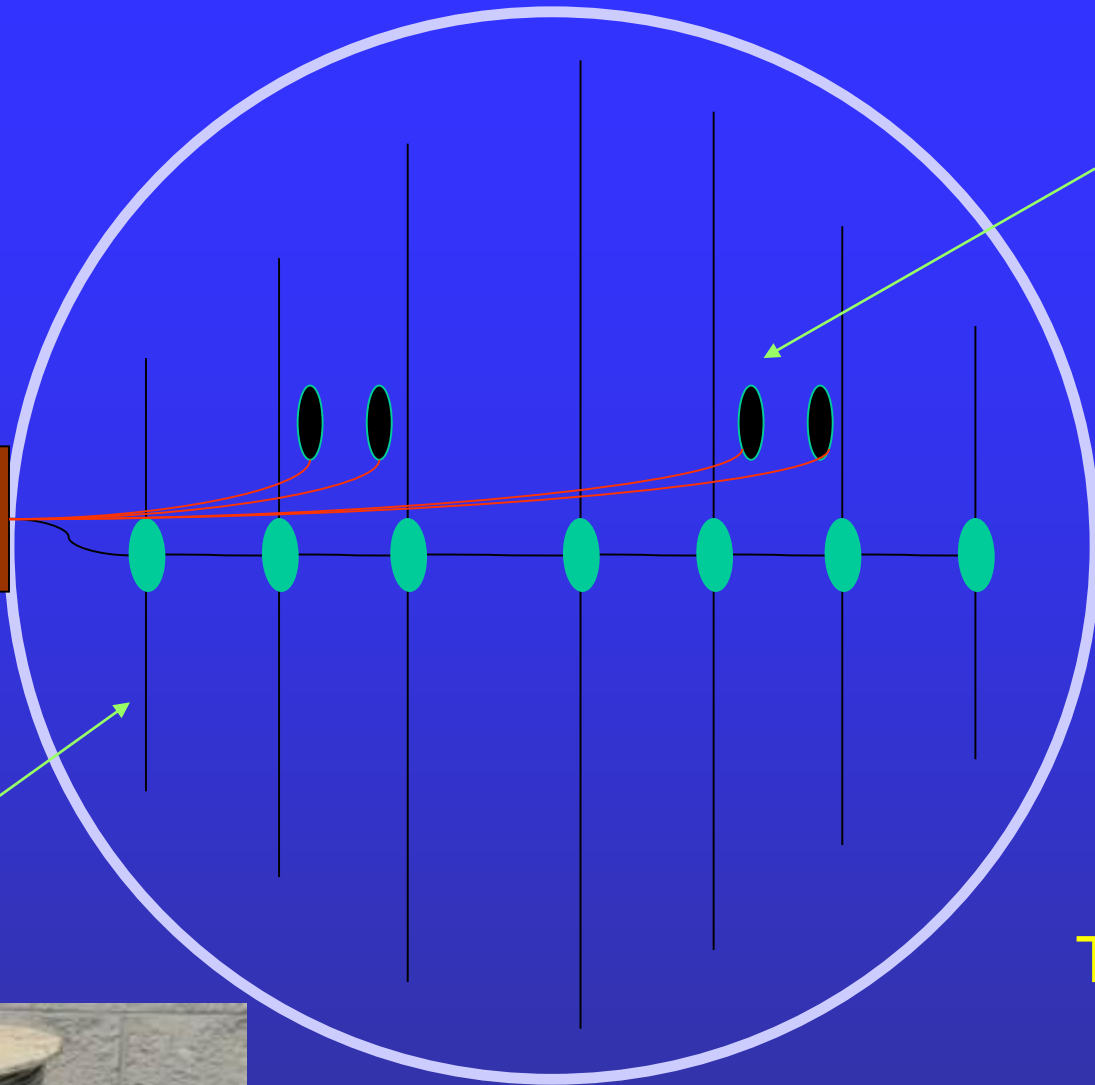
Above Ground Storage Tank With Galvanic Anodes

Is Protection Being Achieved?

Tank Grounded to Other Structures

Uncoated Tank Bottom

Anode

Test Box

Cells

Tank

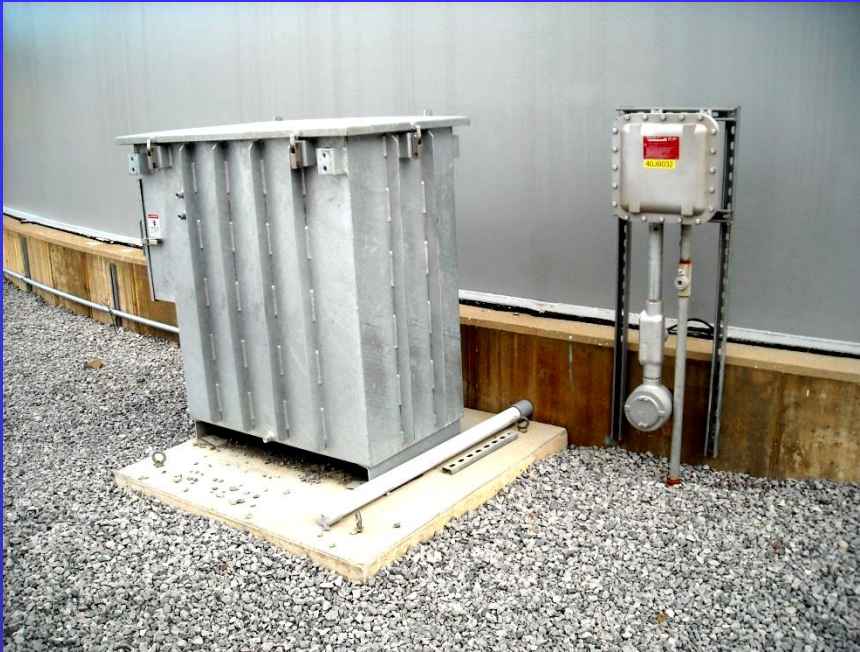
Rectifier Units

Explosion or Non Explosion Proof ?

AC Input ?

AC Availability ?

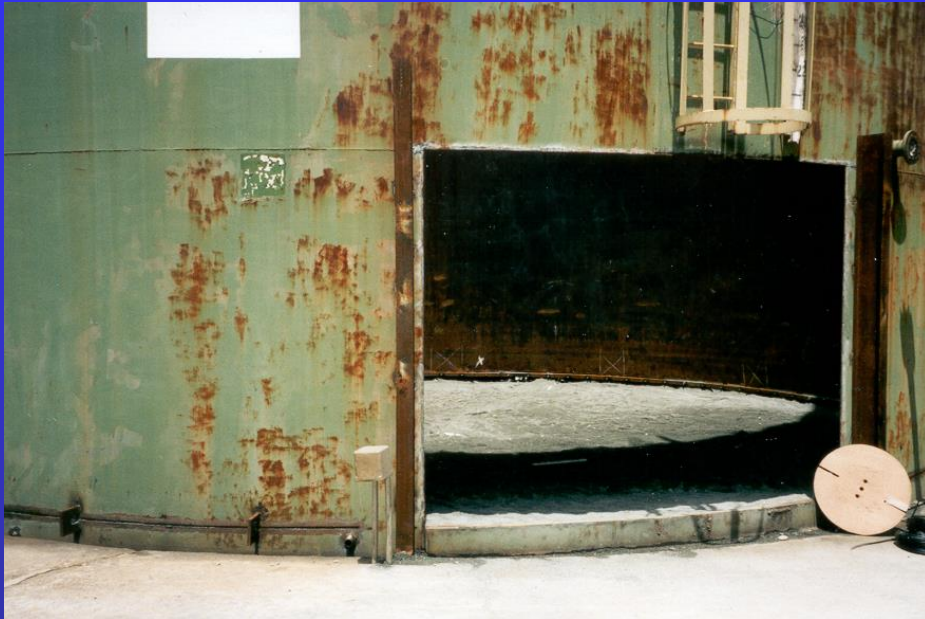
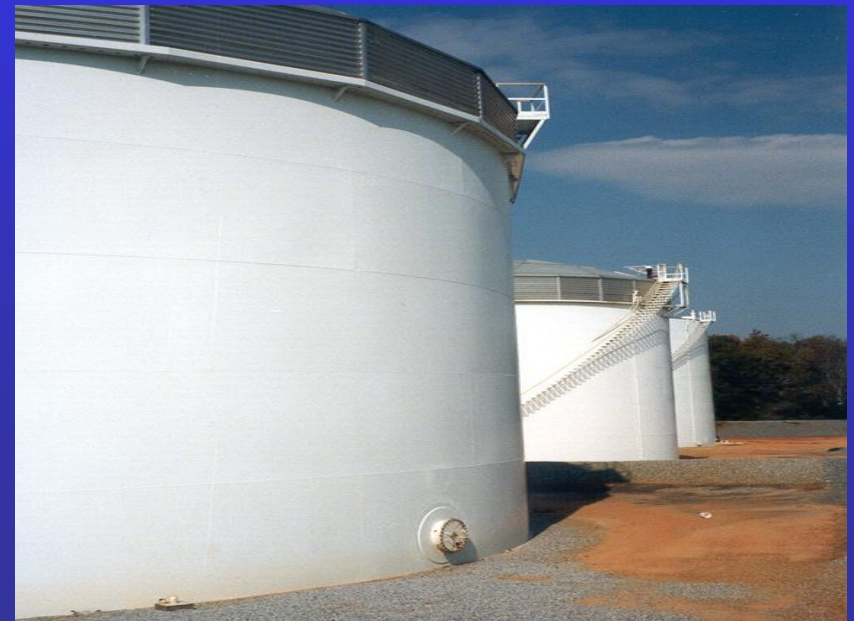
CP Applications for Re-bottomed or New Tanks

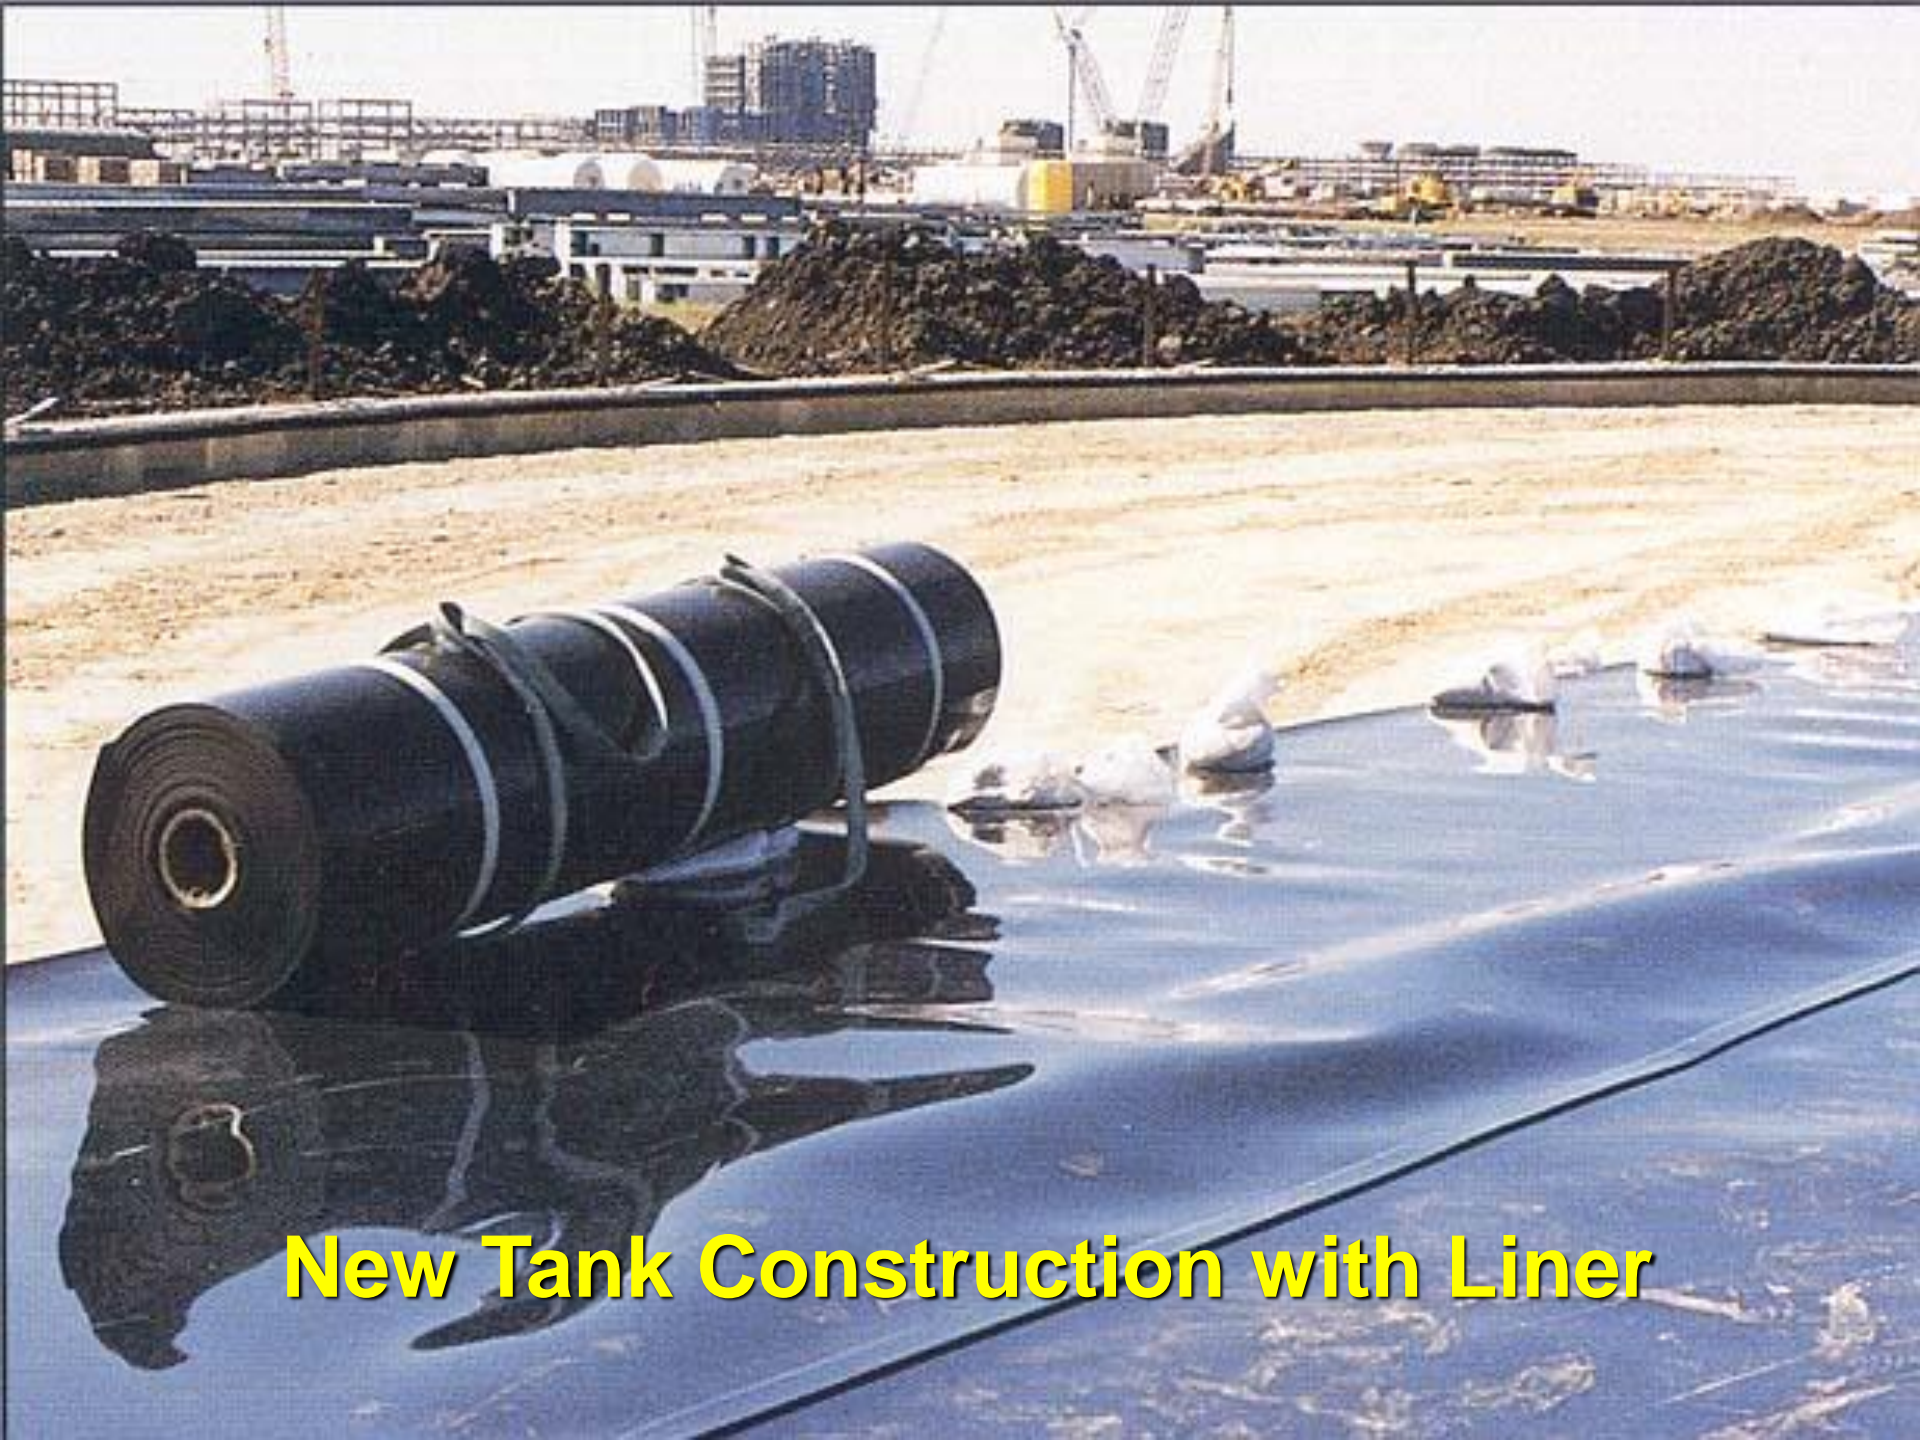
CP Installation on Double Bottom Tank

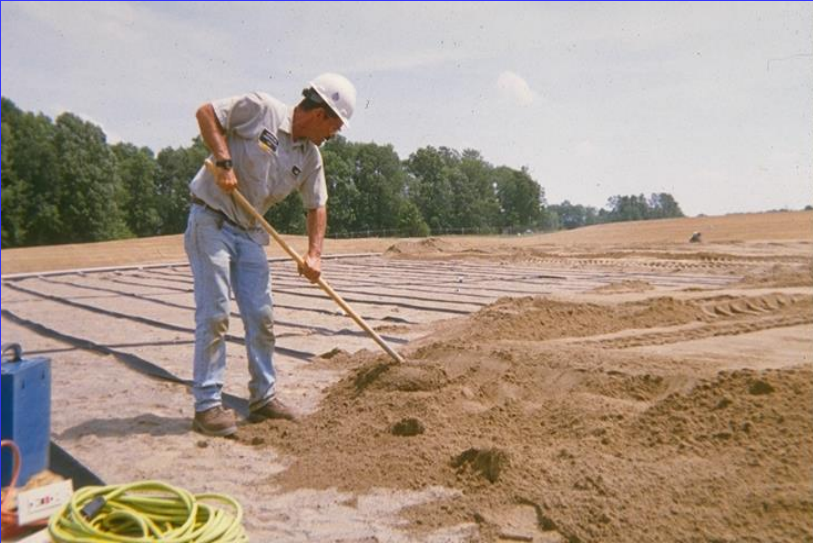
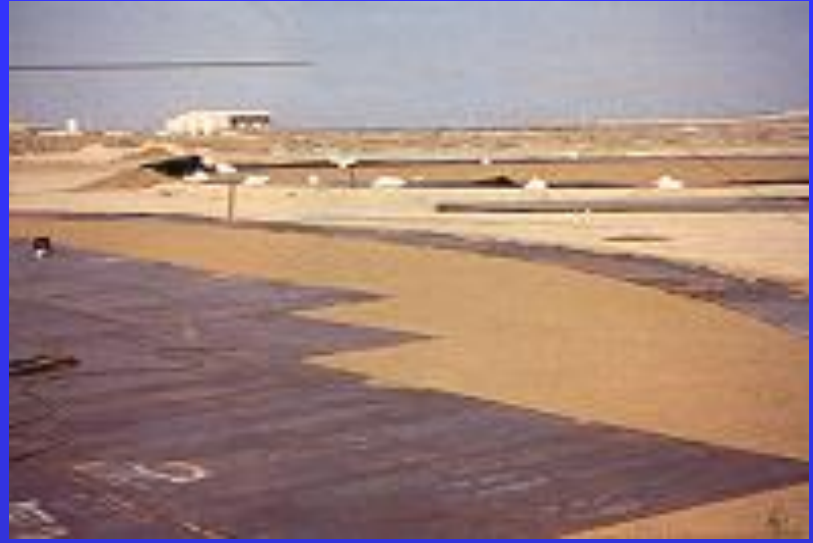
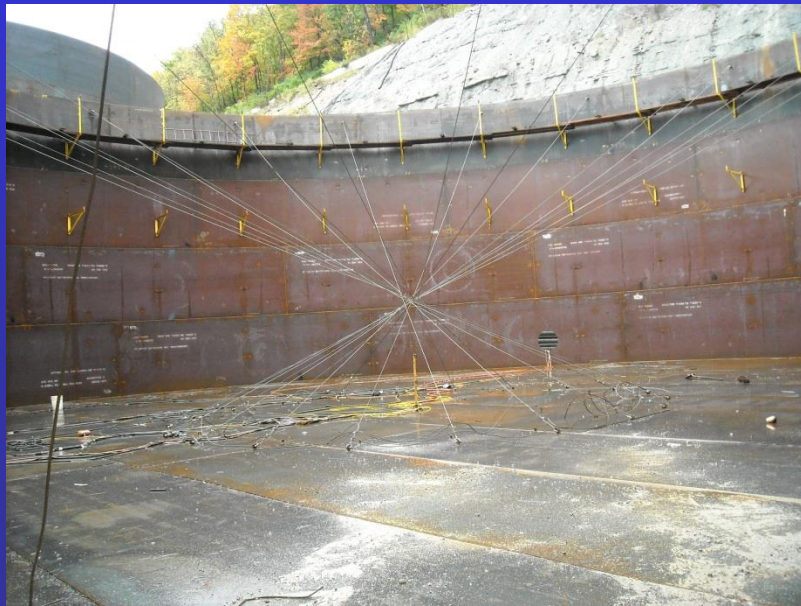
**Anode & Reference Cell Placement
in High Resistance Sand**

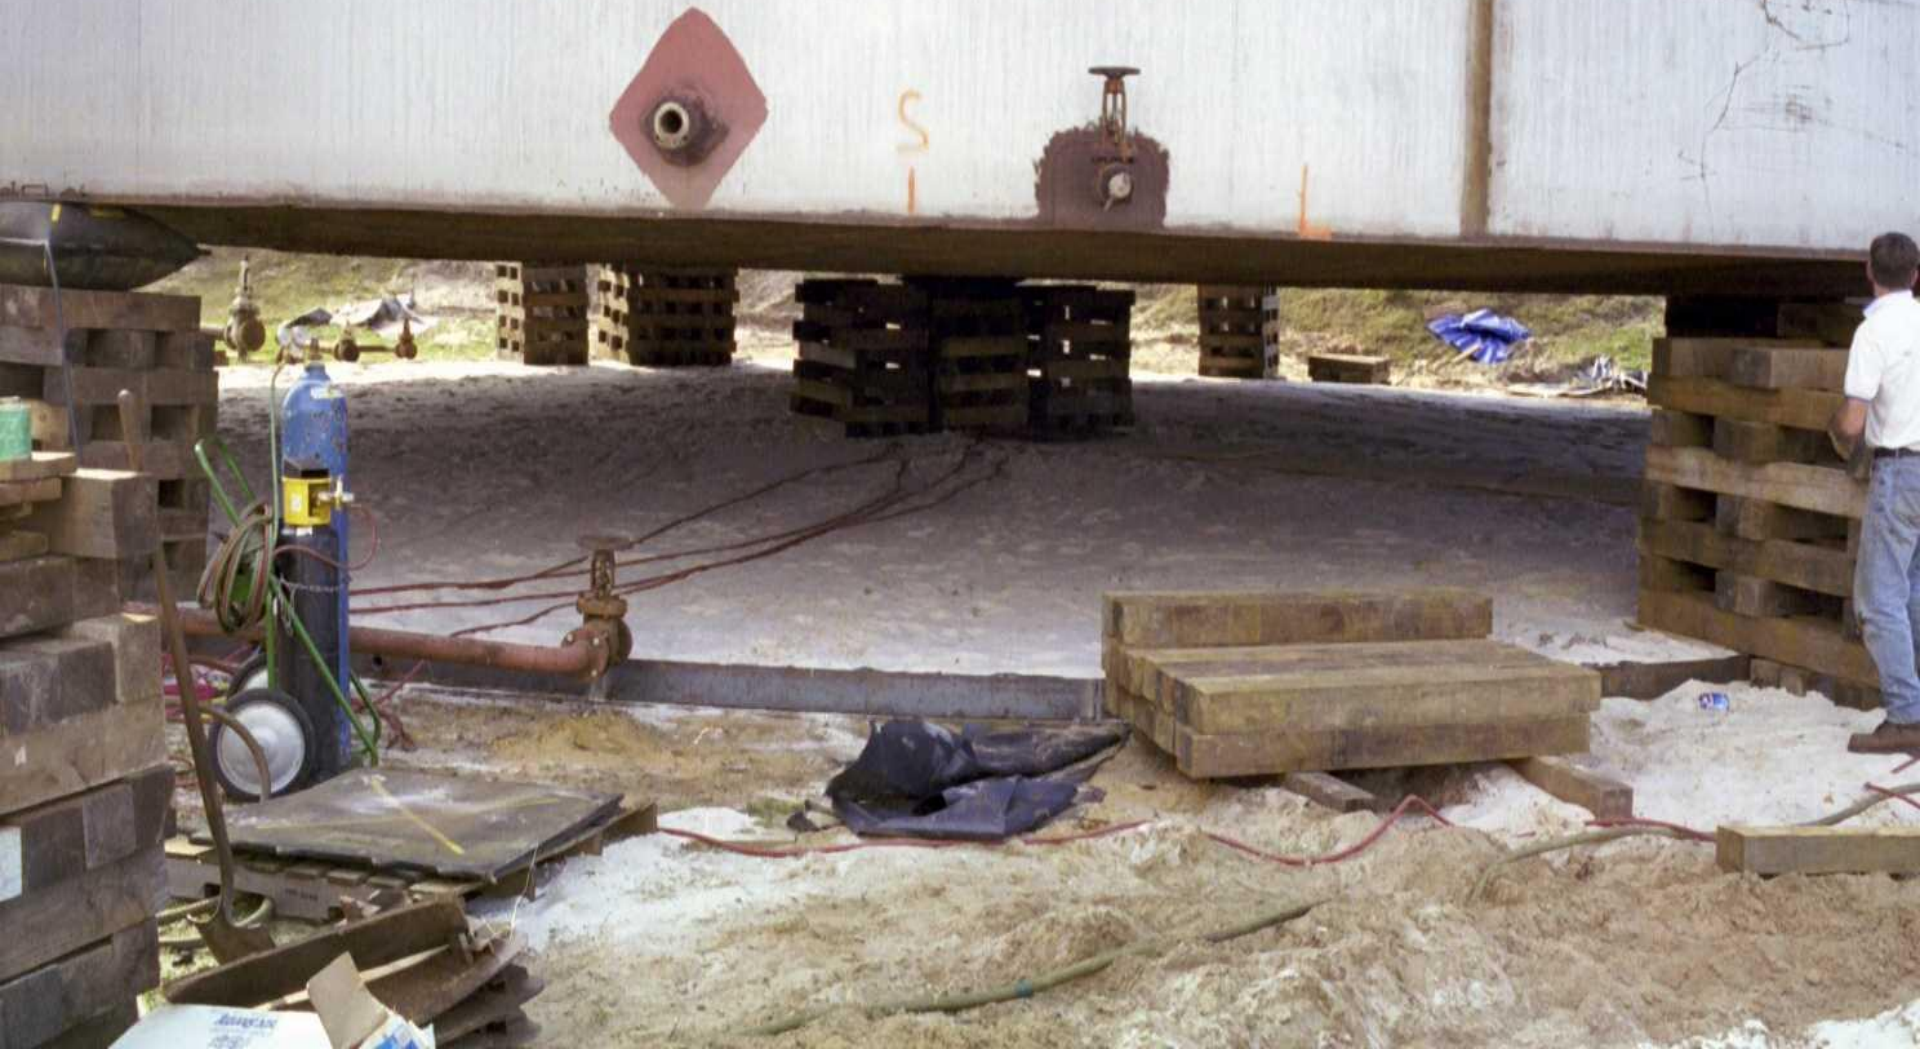
Installation of CP System on Lifted AST

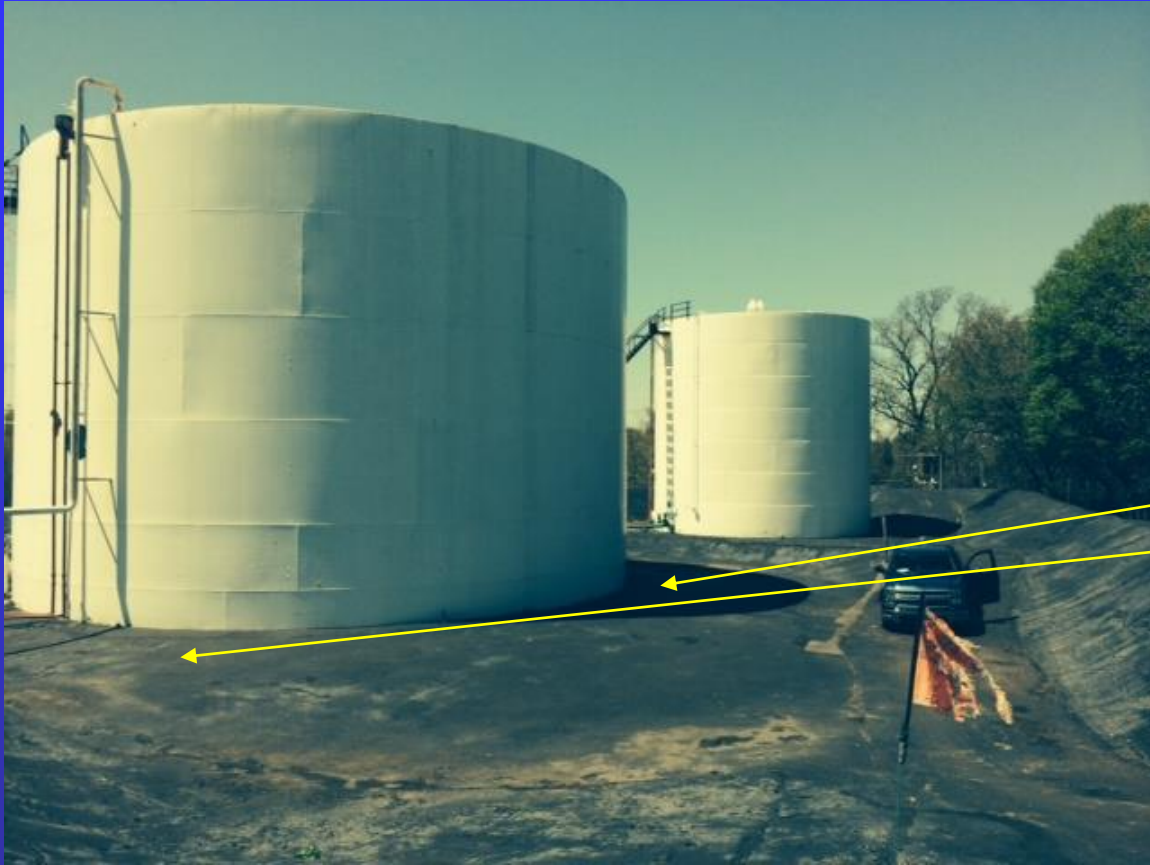
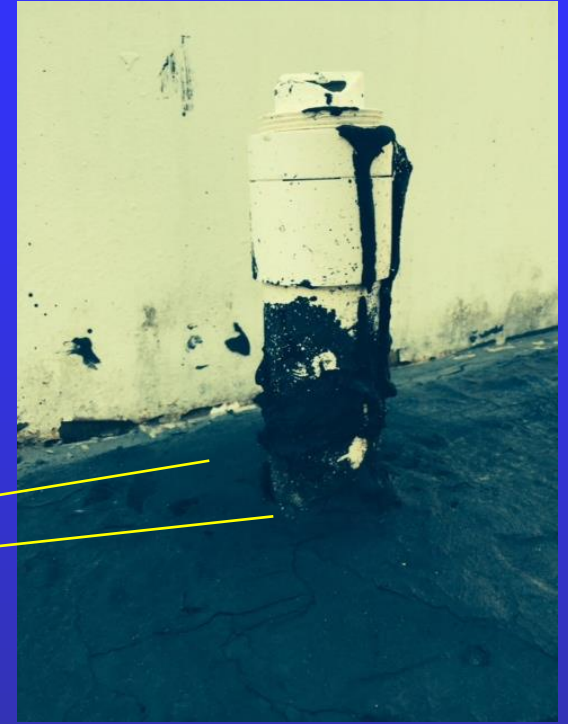
Rim Potential Measurements

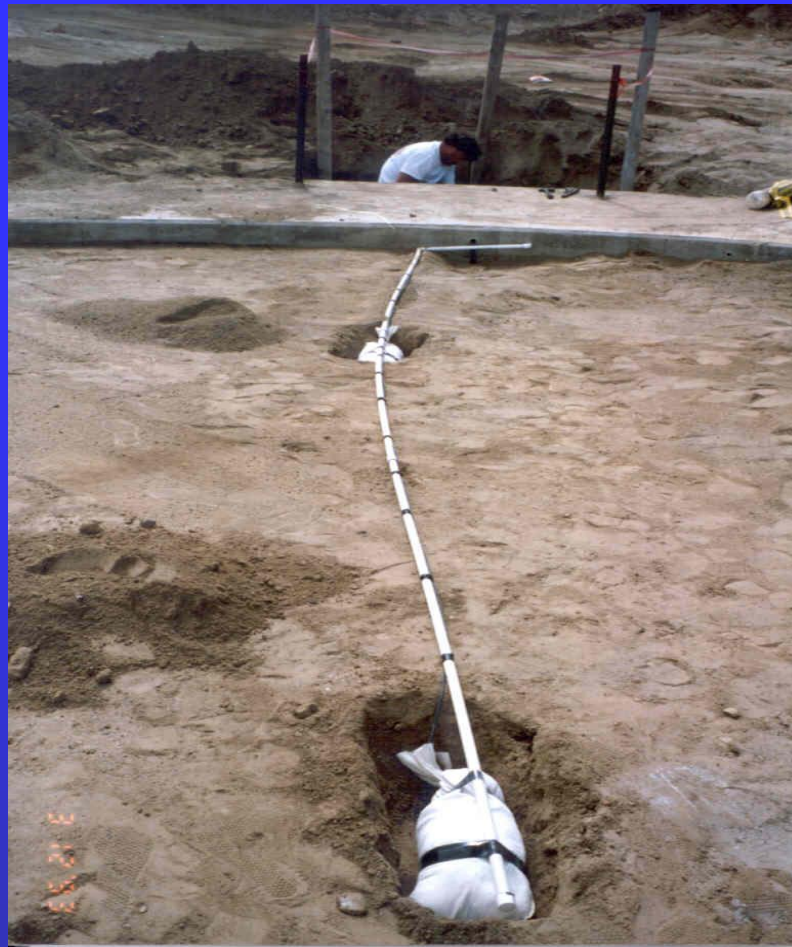
Soil Access Station (Thru Liner or Asphalt)

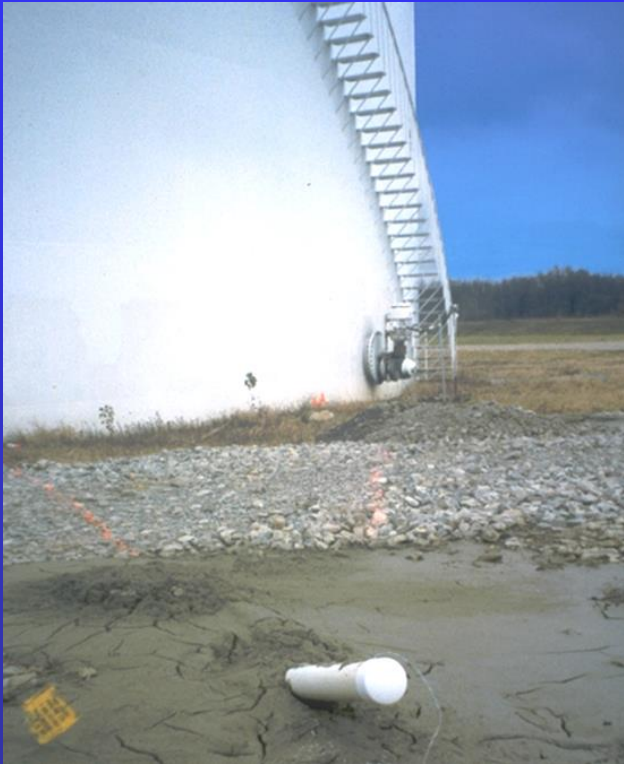
**Reference Cell Placement Under Tank Bottom
(Note obtain and store native readings)**

Reference Cell Monitoring Conduit

Monitoring
Conduit

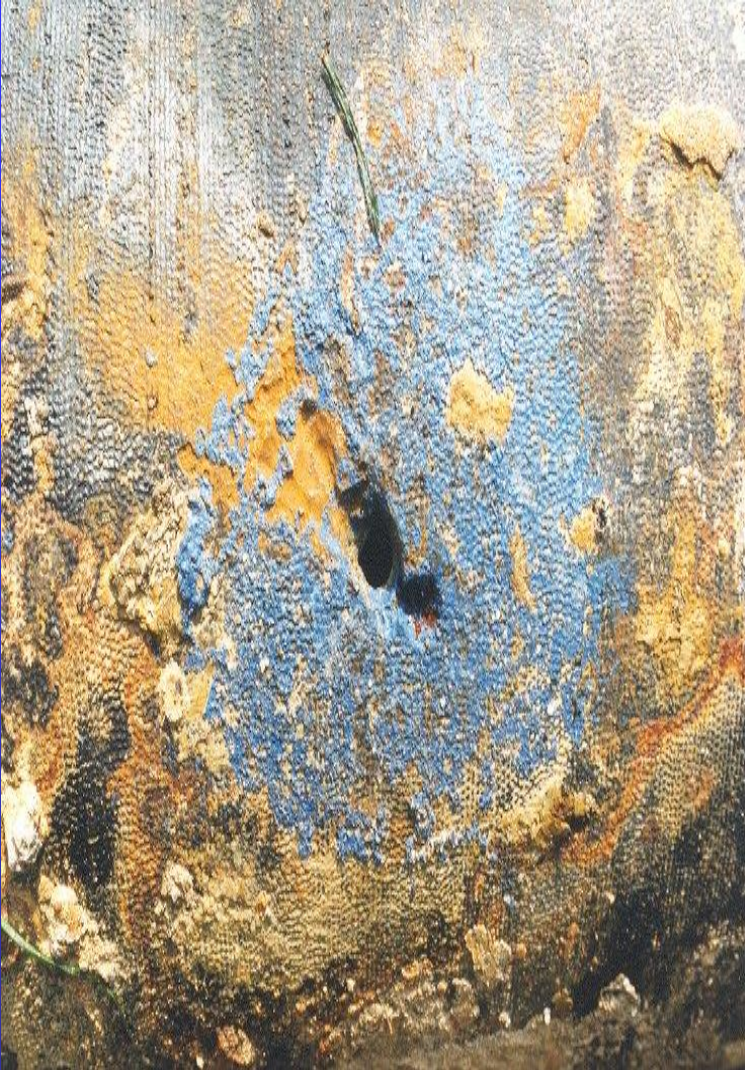
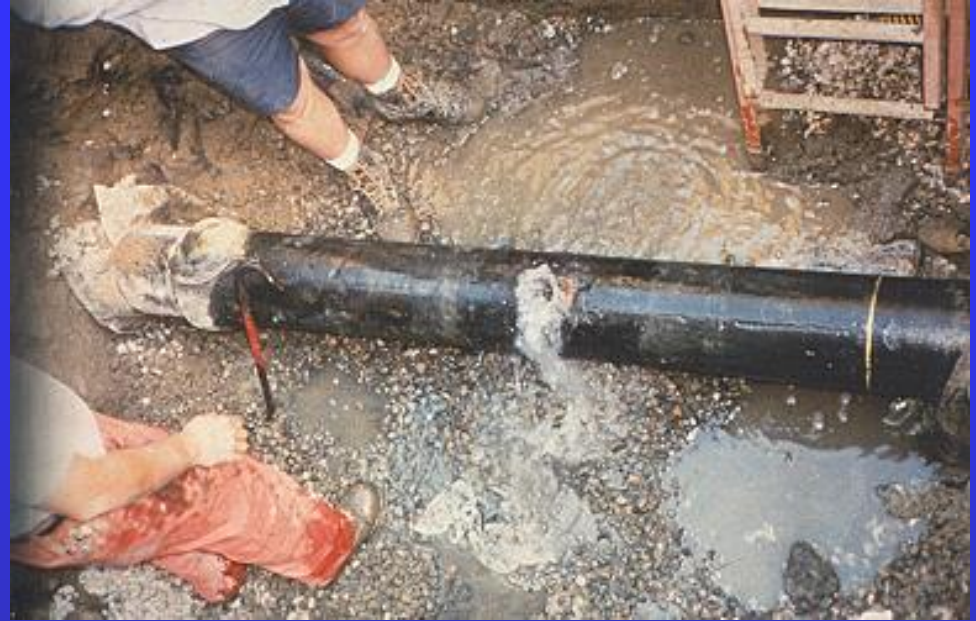
Iron Water Fire Water Piping

Pitting (concentrated)
corrosion attack on ductile iron
pipe.
