# COMMON PIPELINE ANOMALIES

Henry Green

Business Development Manager, Enduro Pipeline Services

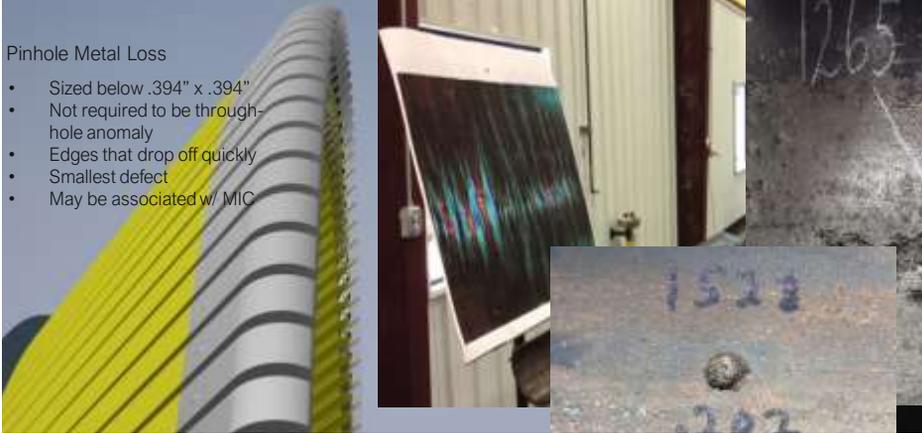
### Pinhole Metal Loss

- Sized below .394" x .394"
- Not required to be through-hole anomaly
- Edges that drop off quickly
- Smallest defect
- May be associated w/ MIC

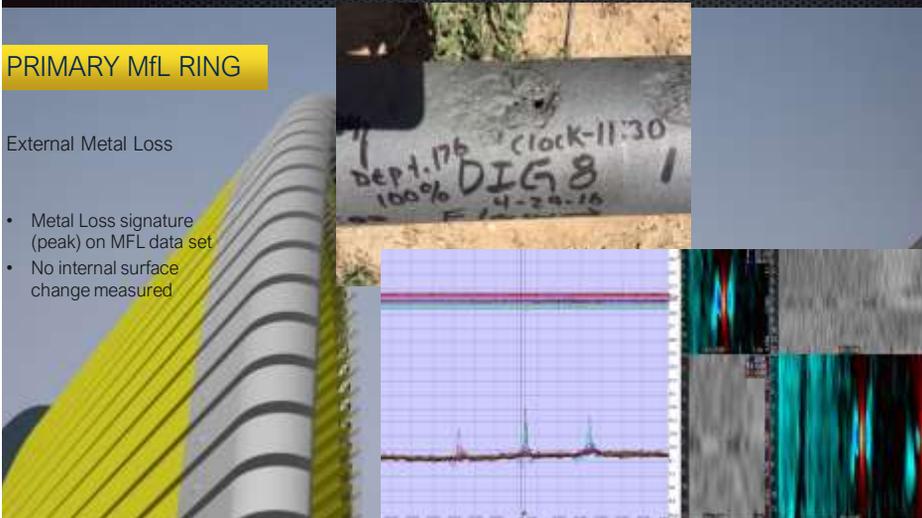
### External Metal Loss

- Metal Loss signature (peak) on MFL data set
- No internal surface change measured

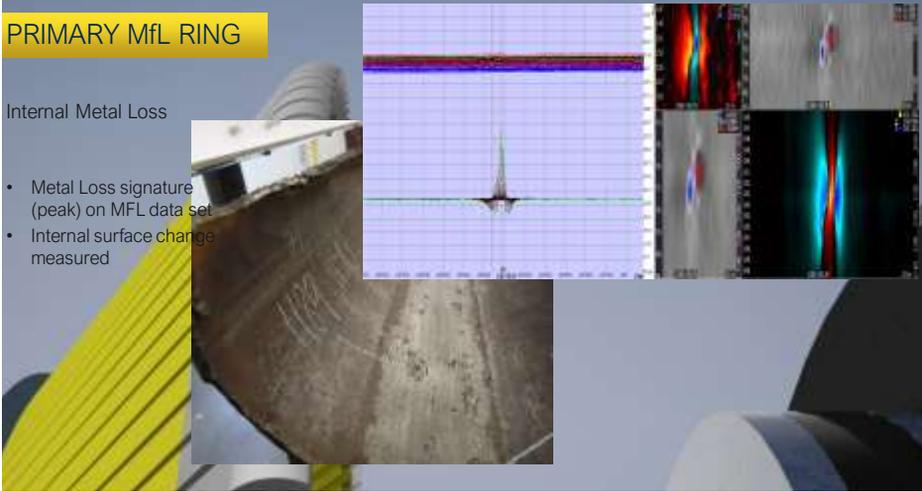
Internal Metal Loss

- Metal Loss signature (peak) on MfL data set
- Internal surface change measured

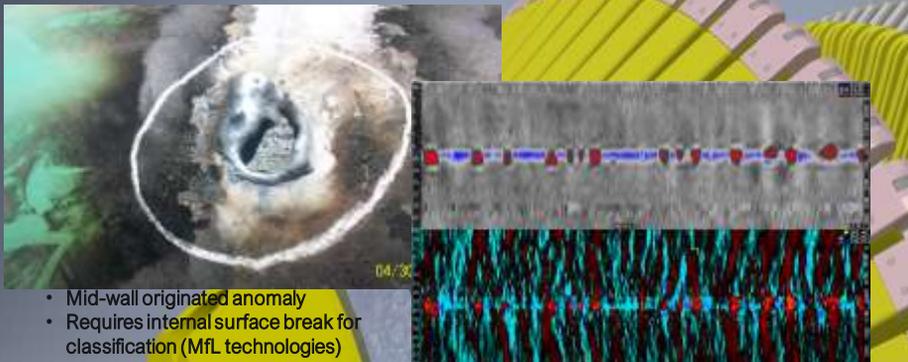
Lamination

- Mid-wall originated anomaly
- Requires internal surface break for classification (MfL technologies)

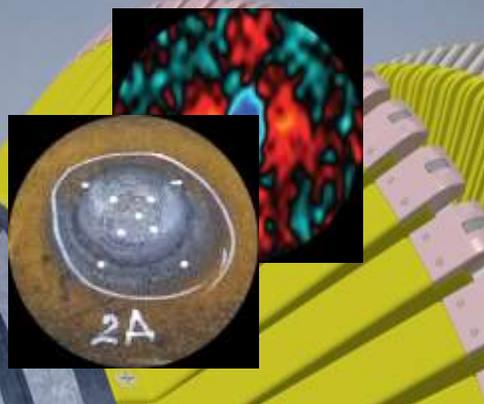
SECONDARY MfL RING

ENHANCES ANALYSIS

Mill Defects

Heat Affected Zones (HAZ)

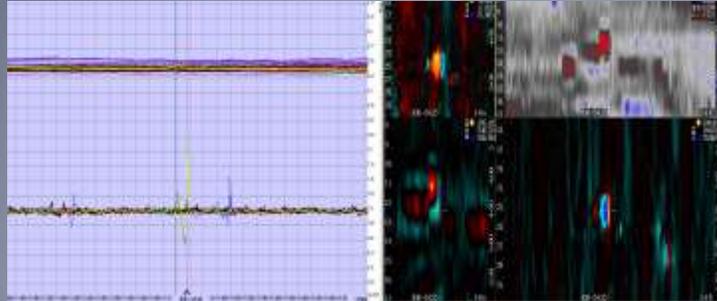
Mill Defects

- Sharp bipolar signal on the MfL and Residual data sets
- Internal surface change measured
- Non-typical Dent or Metal Loss signature

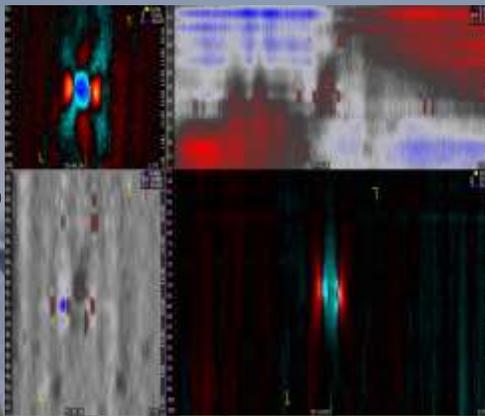
Heat Affected Zones (HAZ)

- Internal surface change measured
- Metals in close proximity (MfL)
- Can make determination between:
  - Type A Sleeves (Reinforcing)
  - Type B Sleeves (Pressure Containing)

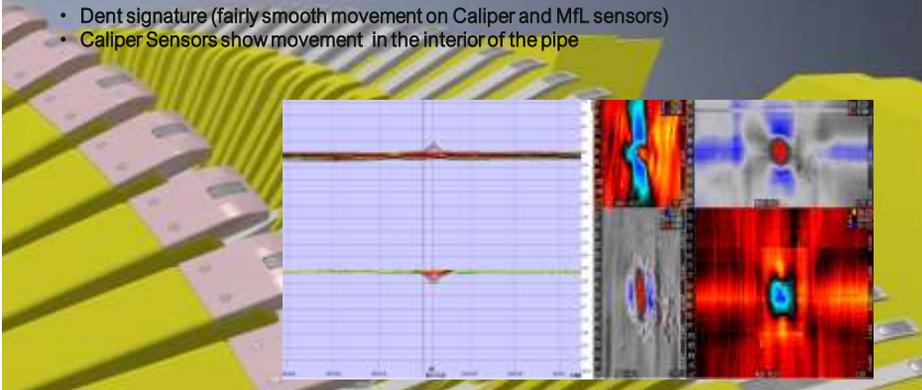
### Dents

- Dent signature (fairly smooth movement on Caliper and MFL sensors)
- Caliper Sensors show movement in the interior of the pipe

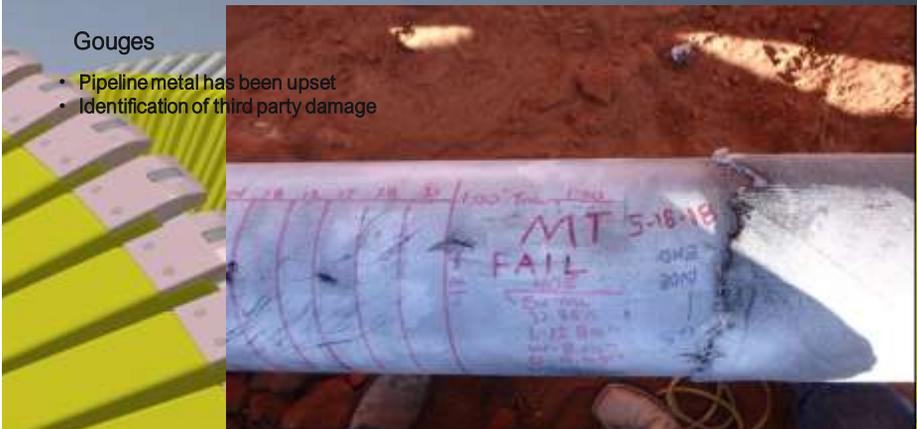
### Gouges

- Pipeline metal has been upset
- Identification of third party damage

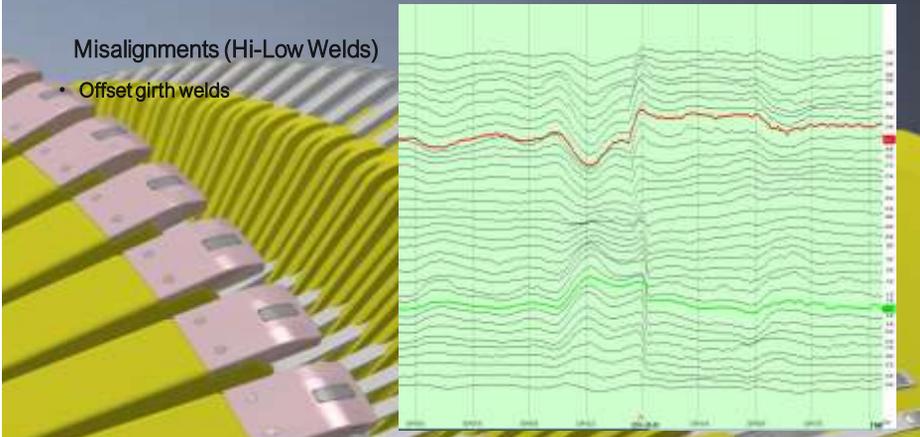
Misalignments (Hi-Low Welds)

- Offset girth welds

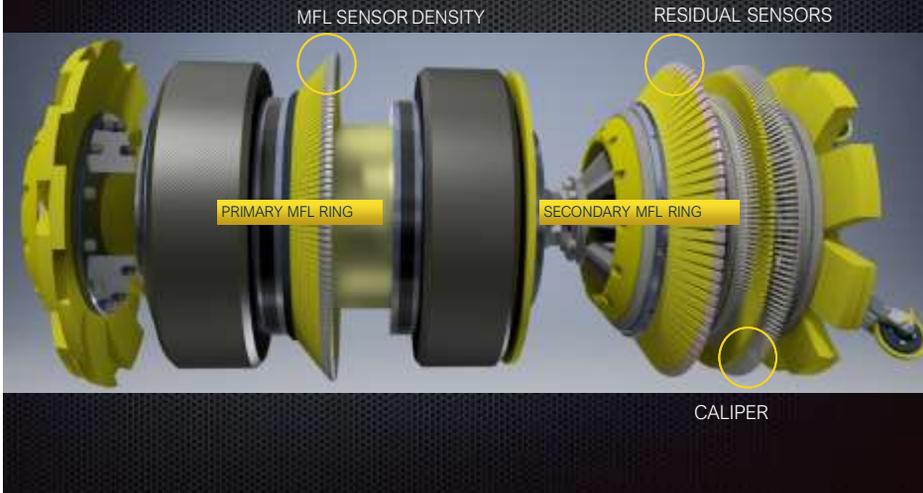
## MfL – Multi Data Sets

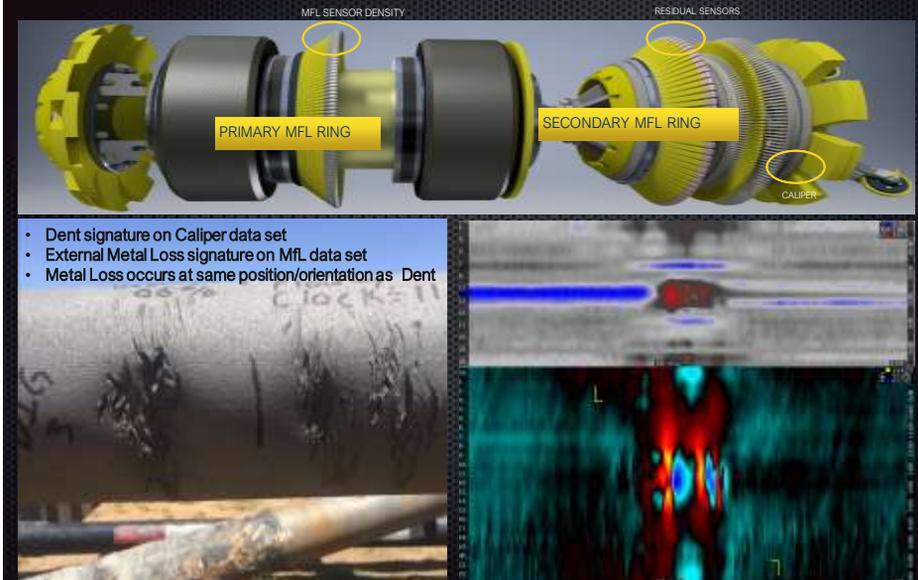
## Dent with Metal Loss

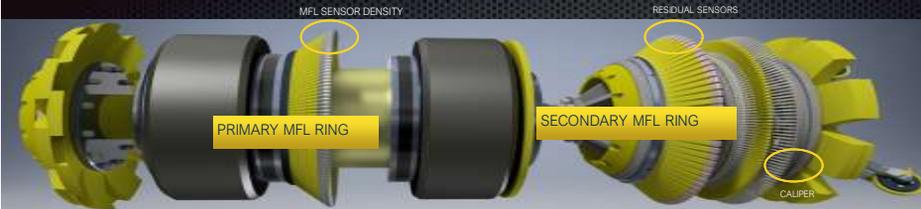
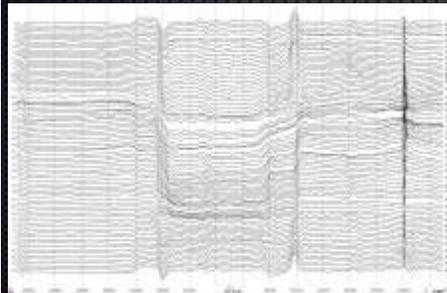
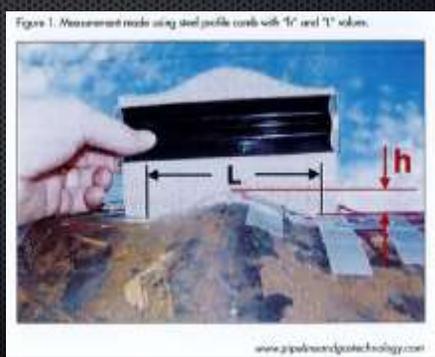
# MfL MULTI-TECH ILI TOOL Expansions

- May occur in complete pipe joint or the middle of a pipe section

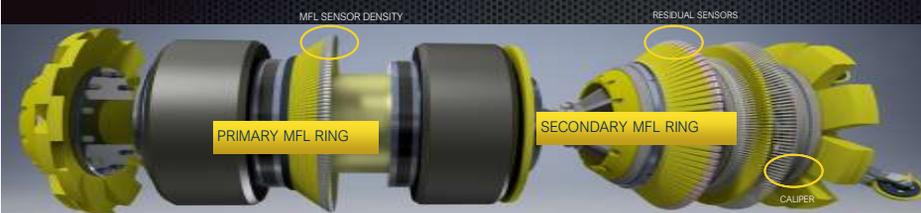
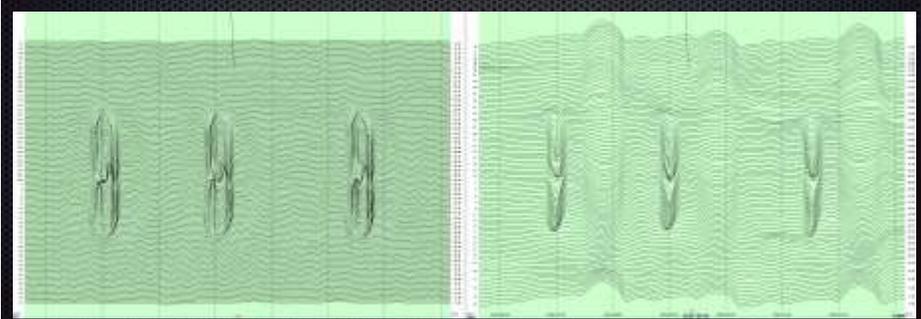
# MfL MULTI-TECH ILI TOOL Wrinkles

- All Caliper Sensors move from baseline

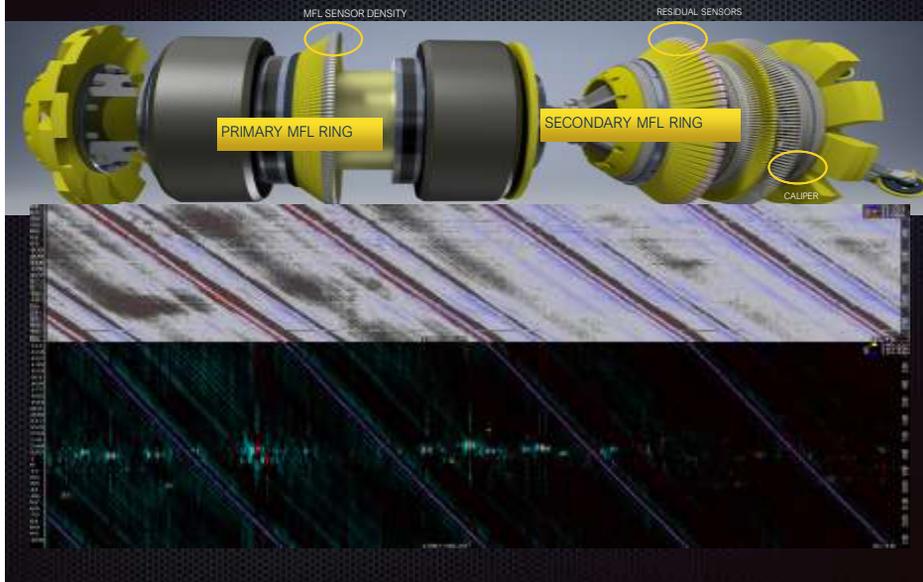
External Metal Loss in Spiral Seam Pipe

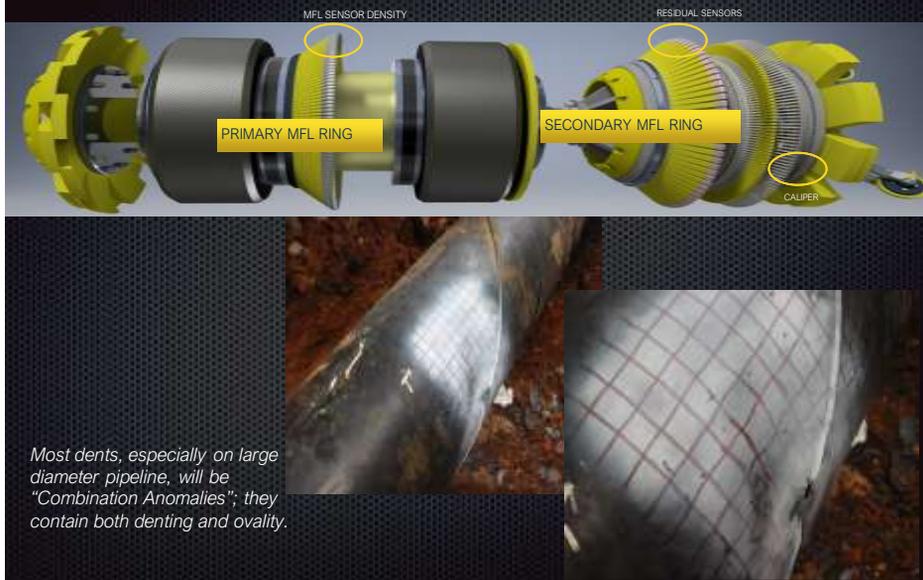
Dent in Spiral Seam Pipe

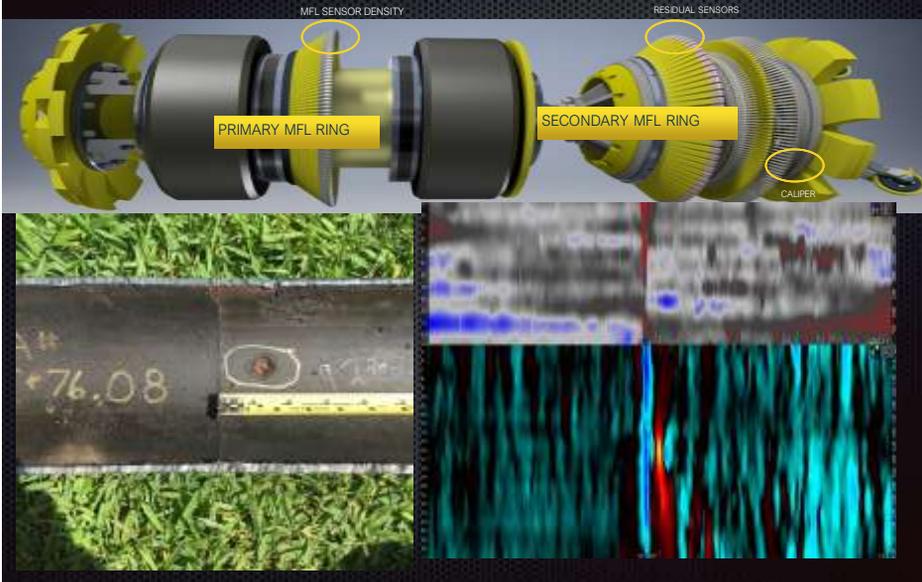
## Internal Metal Loss near Weld

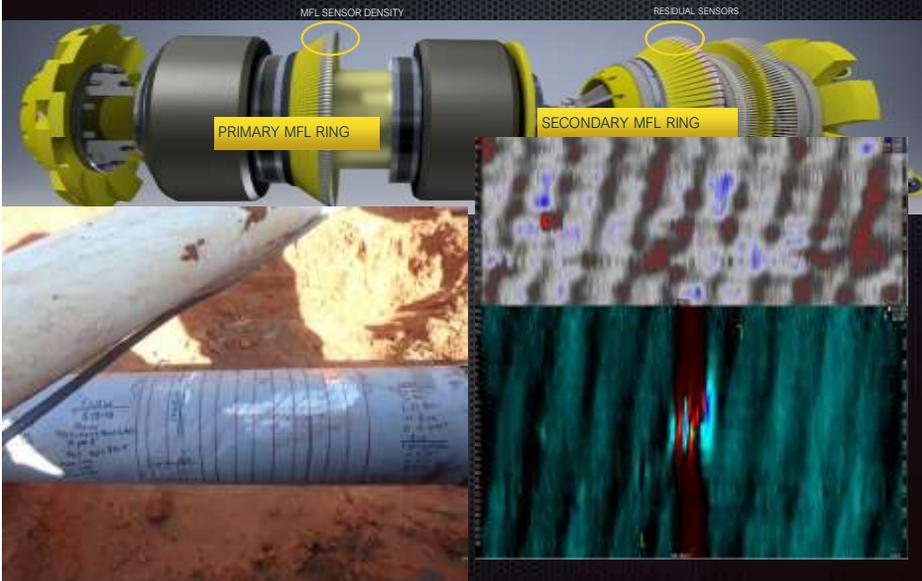
## Gouges
